WINOLA MILL POND DAM

NDI ID NO. PA-00893

**PHASE I INSPECTION REPORT
NATIONAL DAM INSPECTION PROGRAM**

JULY 1979

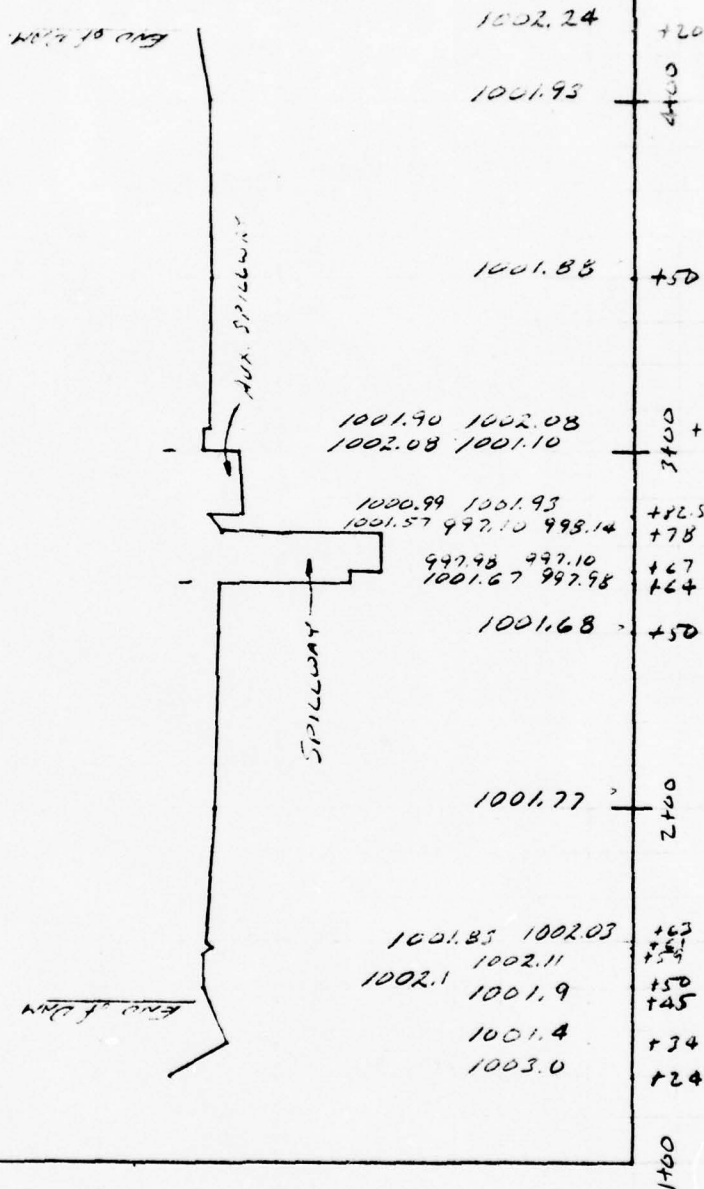
LOOKING DOWNSTREAM
WINOLA MILL POND DAM
PROFILE - TOP OF DAM
SCALES: HOR: 1"=50'
VER: 1"=5'

LINER WALL BULGED
AND SPALLING FOR 10'

SPALLING

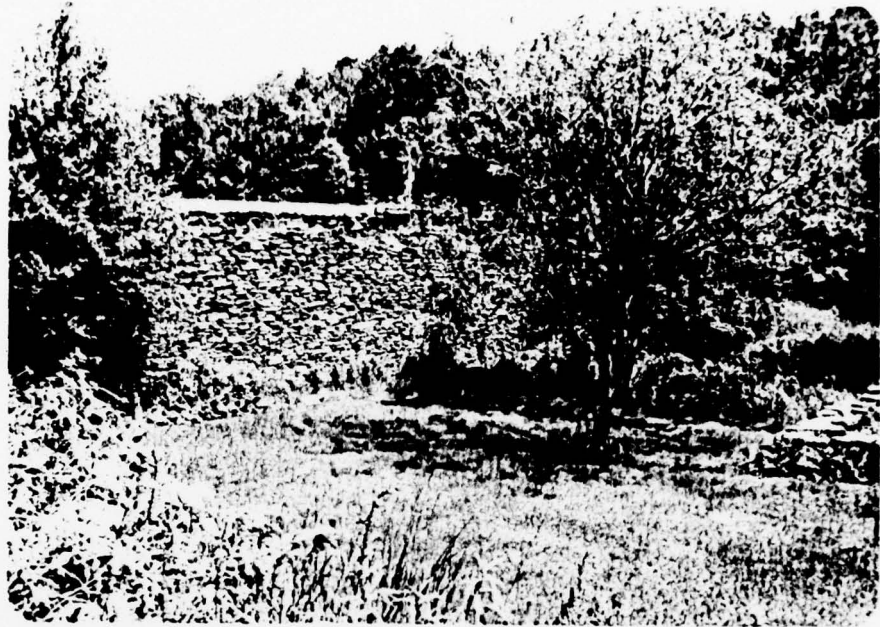
A. Downstream Face

The toe of the dry masonry dam beneath the main and auxiliary spillways is covered with an extensive pile of debris, mostly old timber. The pile is 4 feet high in places and extends for a maximum of 50 feet downstream. The debris obscures the toe of the dam in this area. No seepage was observed at the dam.

Although no seepage was observed at the dam, the debris at the toe of the dam made inspection of this area impossible. If there were seepage at the dam, it would normally be expected to outlet at the lowest area. Since there is debris at the lowest area, no conclusions about

seepage can be reached until the debris is removed. A bulge had previously been reported in the dry masonry. No evidence of it was observed. It may have been obscured by the debris.

(1) Remove the debris from the toe of the dam and then inspect the dam for evidence of seepage, bulging and other conditions. Take appropriate action as necessary.

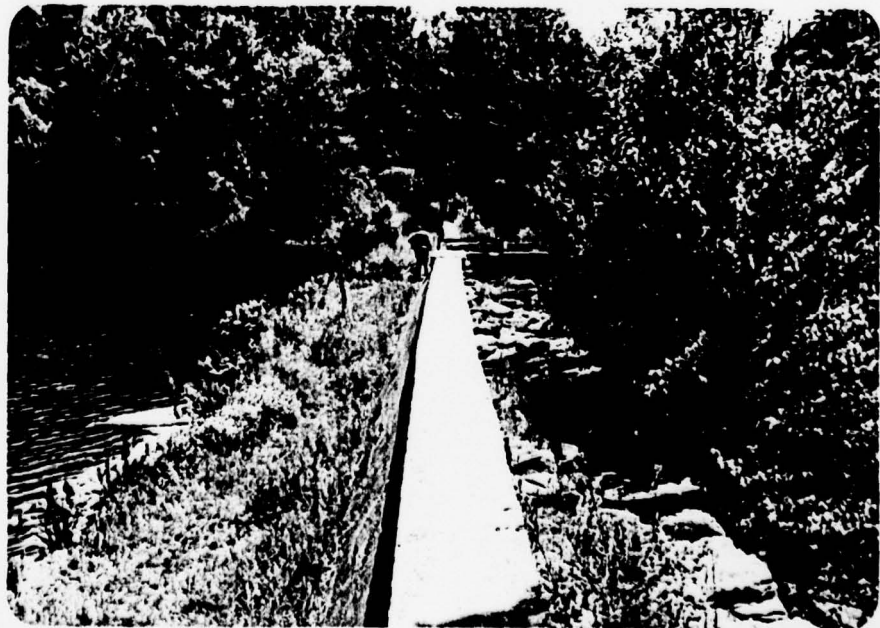
B. Top of Dam

(2) Dry Masonry Dam. Brush and trees on the upstream earthfill are undesirable. The lack of erosion protection on the earthfill is an erosion hazard. The removal of the stones on top of the dry masonry not only increases the probability that the dam will fail if it were overtopped, but their removal also adversely affects the structural stability. Where the stones have been removed beneath the concrete liner wall, the ability of this section to withstand a maximum reservoir load is questionable.

(6) Replace the missing stones on the dry masonry dam and provide measures to prevent further vandalism.

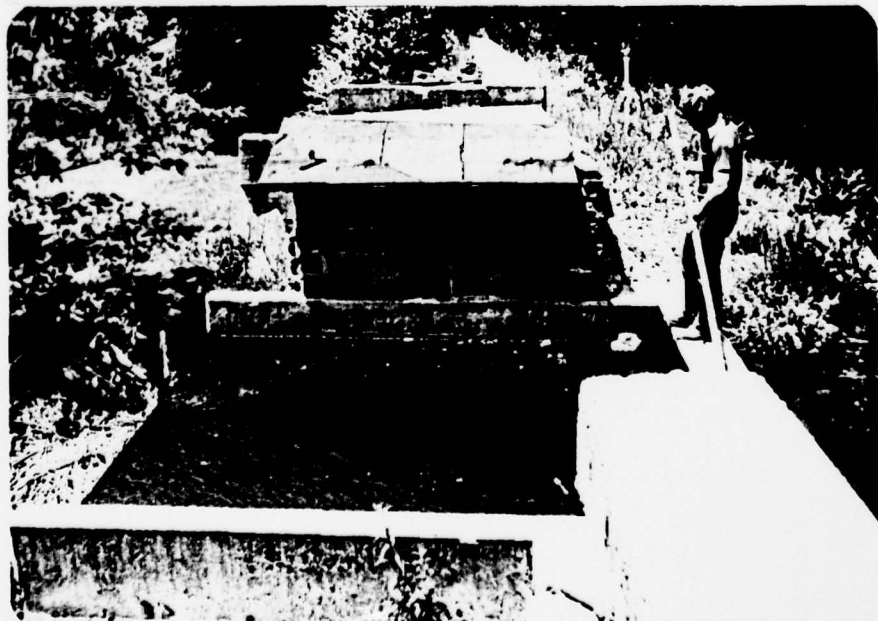
D. Main and Auxiliary Spillways

c. Appurtenant Structures. The main spillway is in good condition. However, the walls are only 1 foot high. The tops of the walls are 4 feet below the design top of the dam. If these walls are overtopped, water would flow over the adjacent dry masonry section of the dam.

The auxiliary spillway is in fair condition. The upstream edge is spalled in areas. The right wall has cracks entirely through it at two places.

(3) Appurtenant Structures. The low walls of the main spillway create a serious erosion hazard. Substantial overtopping of the walls would cause erosion of the dry ma-

sonry and probable failure of the dam. In the analysis described hereafter, the top of dam is assumed to be the top of the main spillway walls. The auxiliary spillway capacity is almost negligible, but it has been included in the analysis.

(7) Repair the cracked concrete liner wall and the cracked and spalled concrete in the auxiliary spillway.

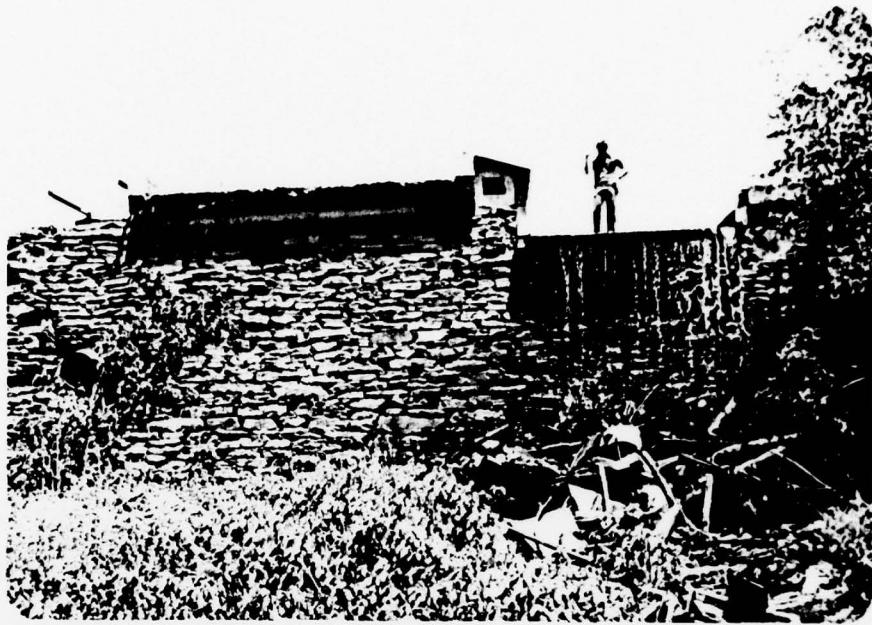
(3) Appurtenant Structures. The cause of the cracks in the auxiliary spillway is similar to the cause of cracking on the concrete liner wall. The outlet works is assessed in Section 5.

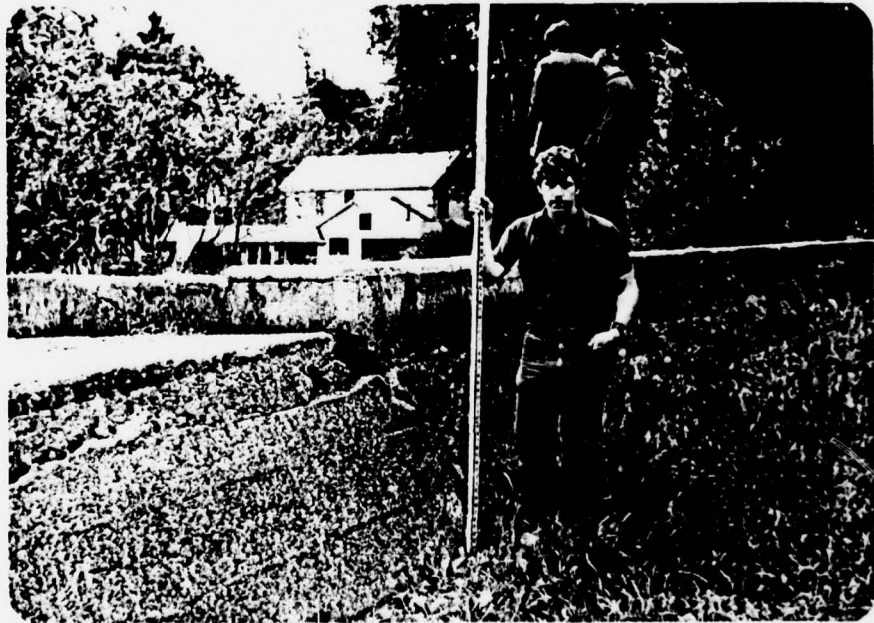
The portion of the concrete liner wall that projects above the upstream earthfill is in fair condition. Numerous cracks, which extend through the concrete, also extend from the top of the concrete down to the earthfill and presumably beyond. The spacing of the cracks varies between 8 and 35 feet. The dry masonry has been removed from the downstream side of the liner wall in certain areas. This leaves the liner wall with little support. The liner wall is bulged and spalled over a 10-foot length at the left abutment. At the right abutment, the wall deflects upstream about 5 degrees; it is not known whether this deflection was planned or whether it occurred after the wall was constructed.

The cracks in the liner wall are of concern. If they extend beneath the earthfill, fines from the earthfill have the potential to pipe through the cracks into the coarse dry masonry. In view of both the hole that developed in the earthfill and the reported leakage before the 1964 modification, the situation has potential hazards. As there are no contraction or expansion joints, the cracks probably developed because of shrinkage and temperature fluctuations. As the dam has reportedly settled over 2 feet since 1919, this could also be a contributing cause for the cracks. The cause of the conditions at the liner wall adjacent to the abutments is unknown; the conditions could be an indication of movement of the dam. The shelter and associated hole in the liner wall allow water to flow through the dry masonry when the pool is substantially above main spillway crest. This is undesirable.

F. Cracking on Upstream Concrete Face

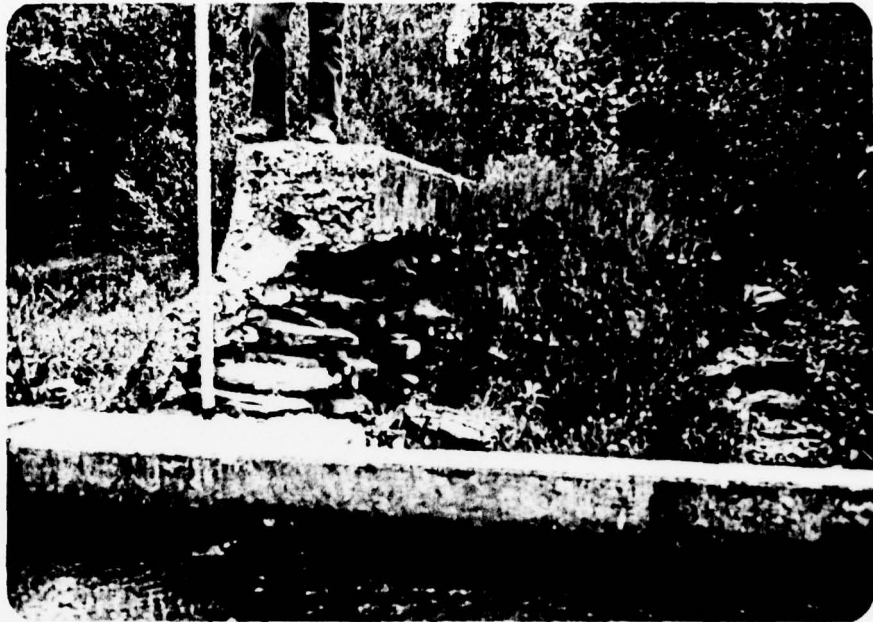
G. Area Left of Main Spillway

(2) Dry Masonry Dam. As noted previously, the erosion to the left of the main spillway indicates that the main spillway walls have been overtopped. The low areas at the top of the dam reduce the spillway capacity.

(5) Remove the shelter near the main spillway and make repairs to the eroded area to the left of the main spillway.
